COLD SPRAY PORTABLE LOW PRESSURE

FLEET READINESS CENTER

LOW PRESSURE COLDSPRAY

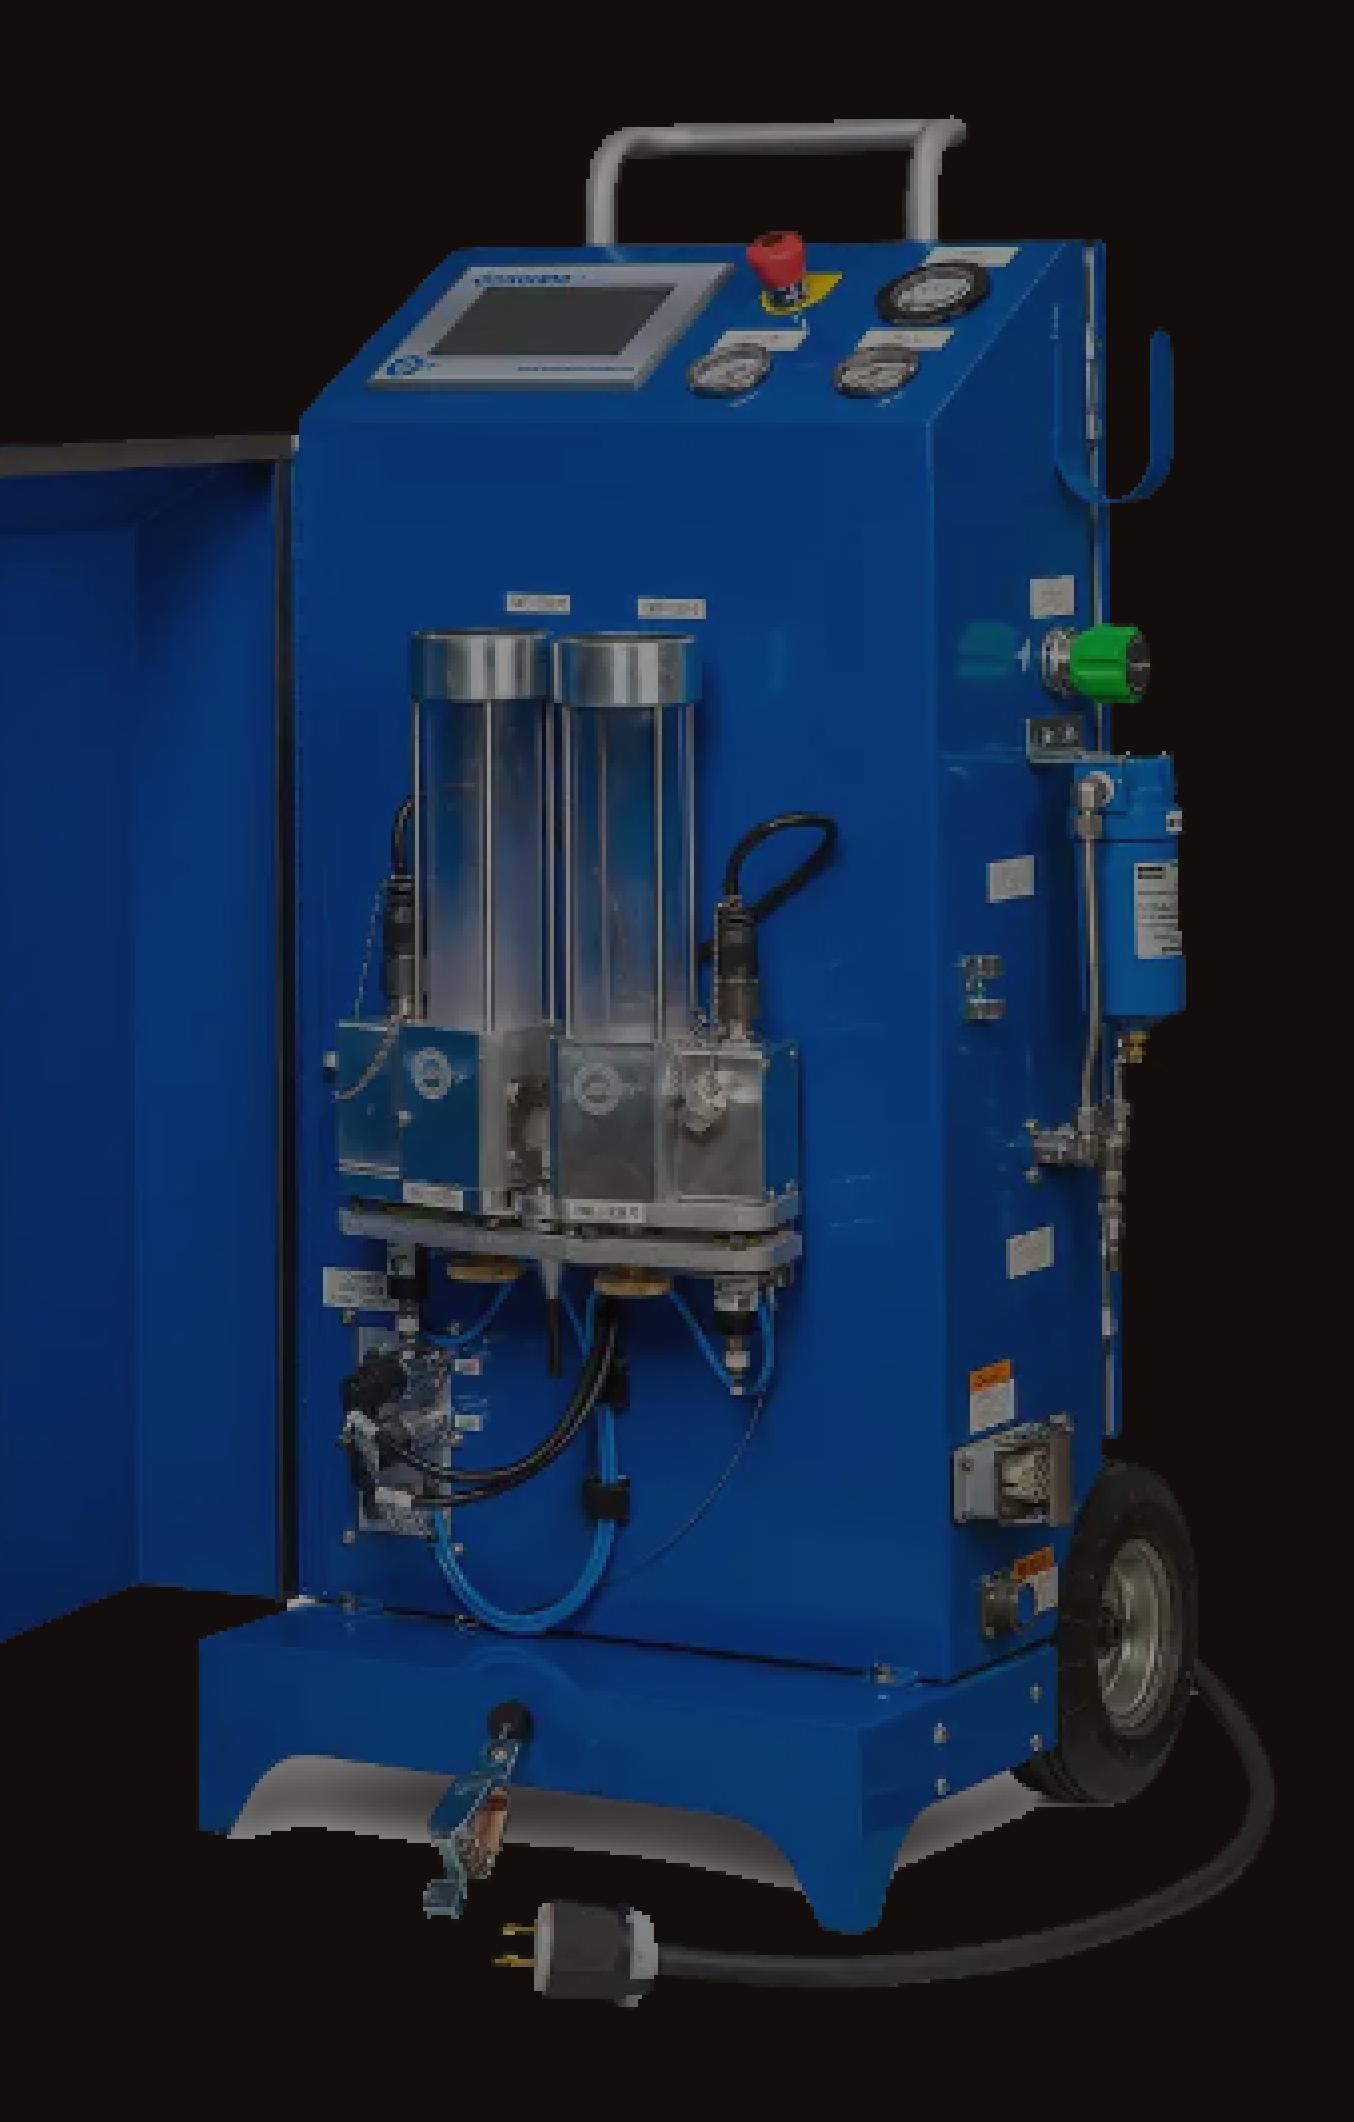
CENTERLINE PX

- Low cost, highly versatile, portable, and hand-held operation.
- Multiple approved aircraft repairs.
- Placement and training at various Navy Intermediate (I-Level) sites funded by POM-23, deployments starting in spring 2-24
- Use for on-aircraft corrosion restoration (i.e., blend and fill) instead of using sealants or epoxy
- Operated using Nitrogen or Compressed Air

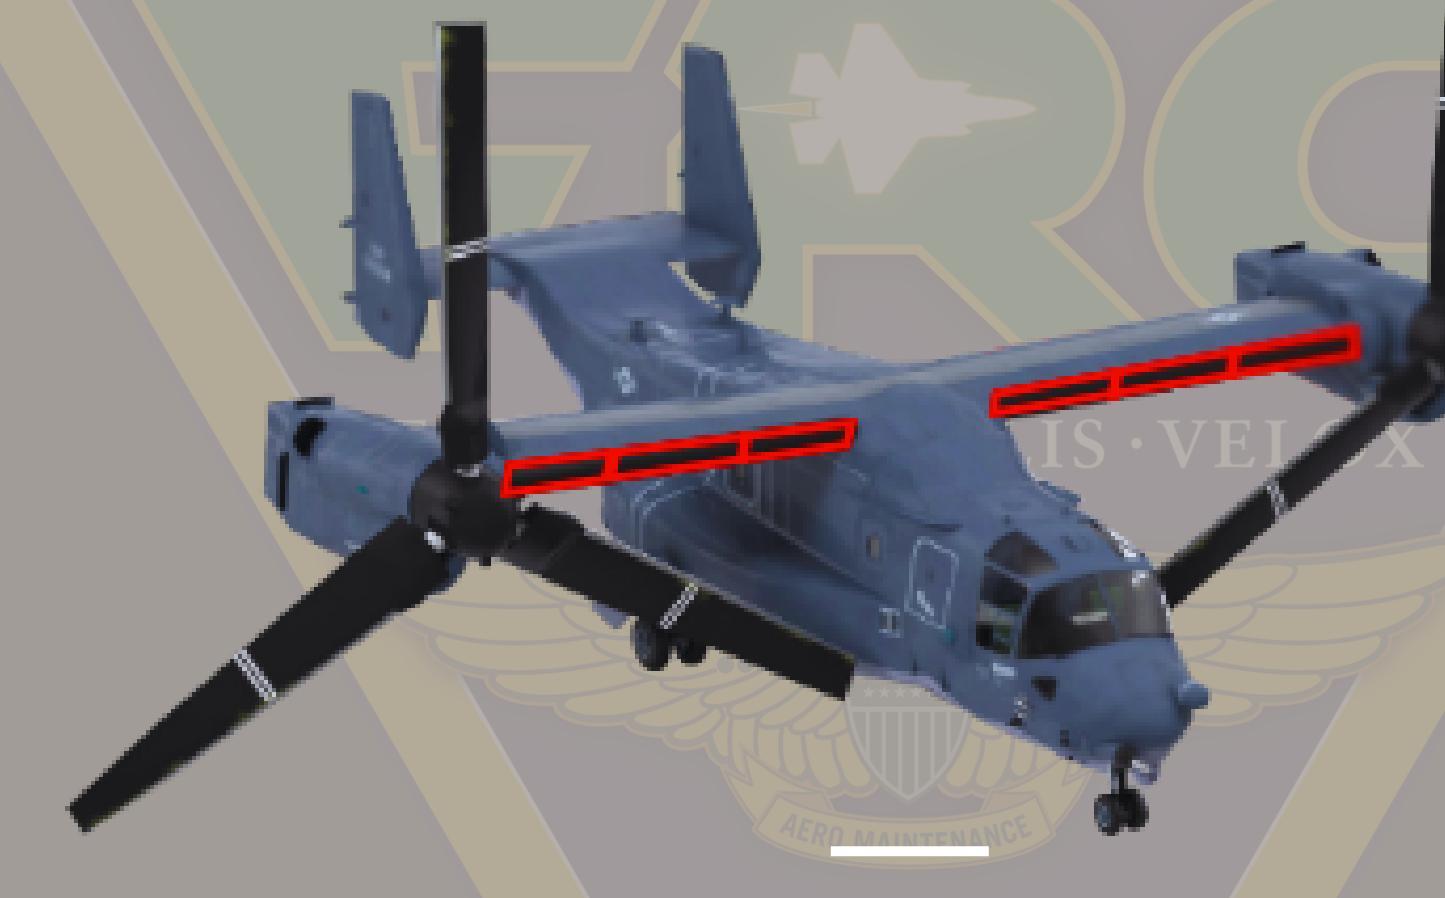
FLEET READINESS CENTER V-22 LEADING EDGE PANEL

Problem: Severe pitting corrosion on lower fastener line around fastener holes
Scope: Corrosion causes full replacement of six panels per aircraft during PMI, which costs roughly \$180k
Solution: Restore dimensional loss from corrosion and improve protection by adding epoxy primer
Benefit: Increased parts available

Decreased cost and lead-time

Repair cost is 30% of a new panel. Enable I-level capability for fleet repair

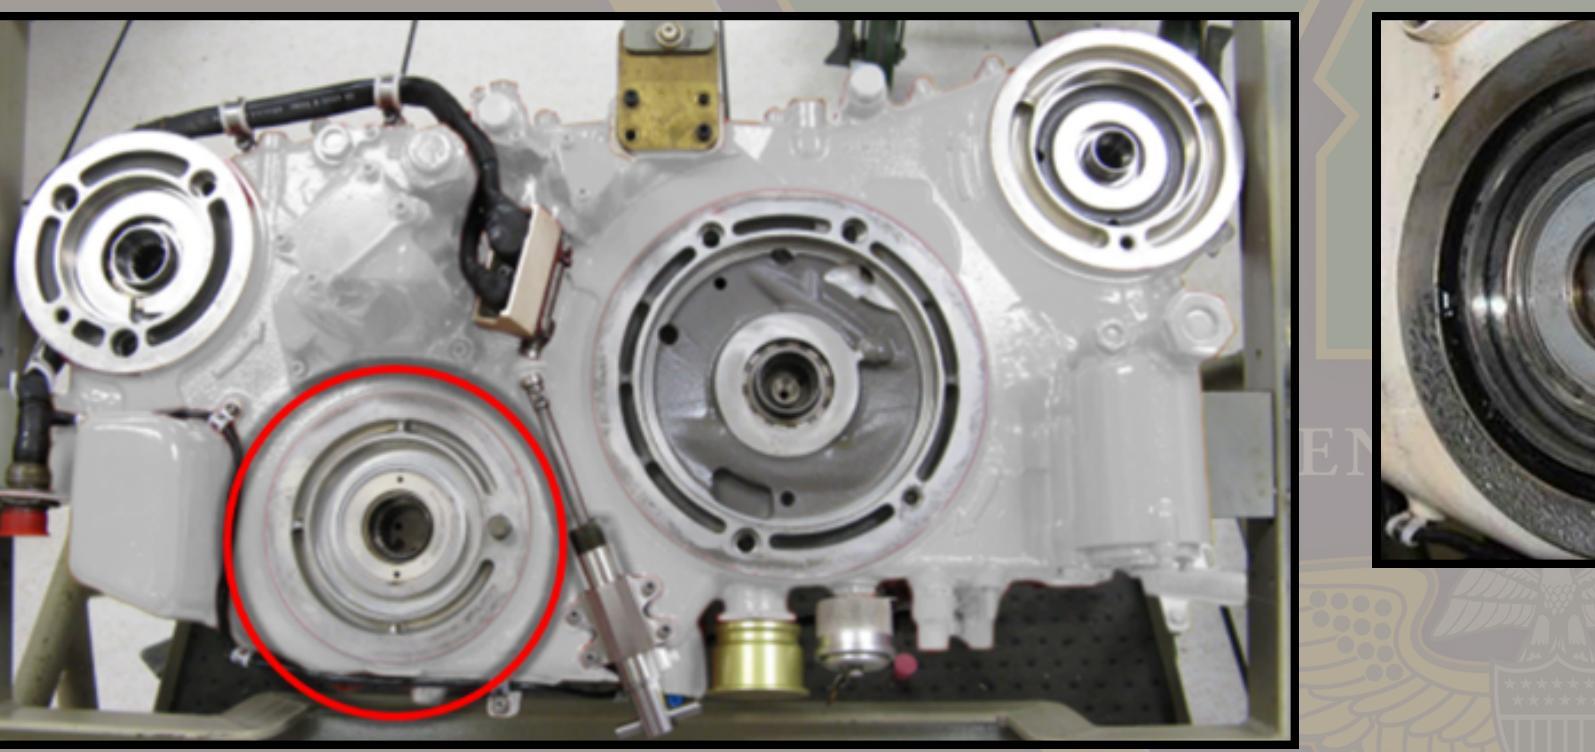
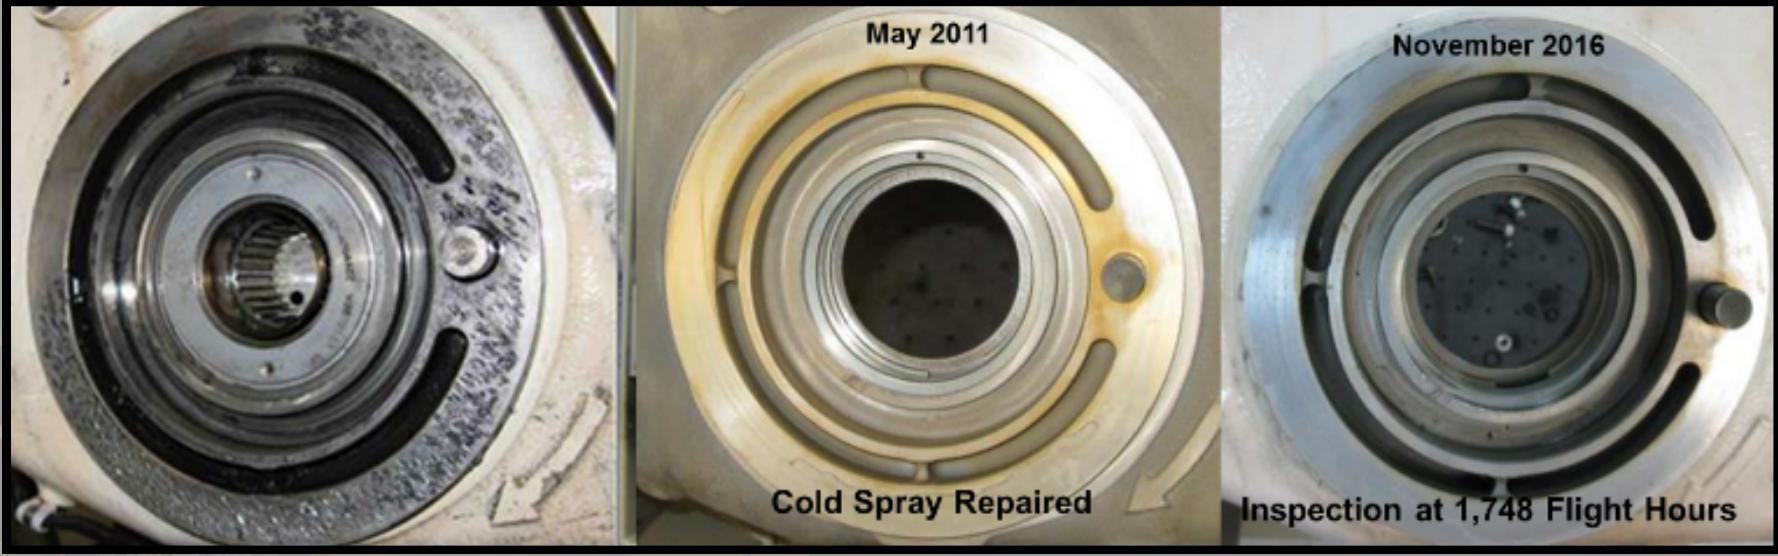
FLEET READINESS CENTER F/A-18 E/F Gearbox

HYDRAULIC PUMP

Problem: Fretting damage on the Hydraulic Pump pad. F/A-18 Gearbox is a complex aluminum casting that has large cost and lead time **Scope:** Two gearboxes per aircraft each costing over \$200k **Solution:** Restore dimension to the sealing surface **Benefit:** Repaired and returned to service since 2011 Over 35 Gearbox have been repaired, totaling over 19,000 flight hours saving over \$7 Million First NAVAIR approved Cold Spray repair

FLOWN 1,758 HOURS

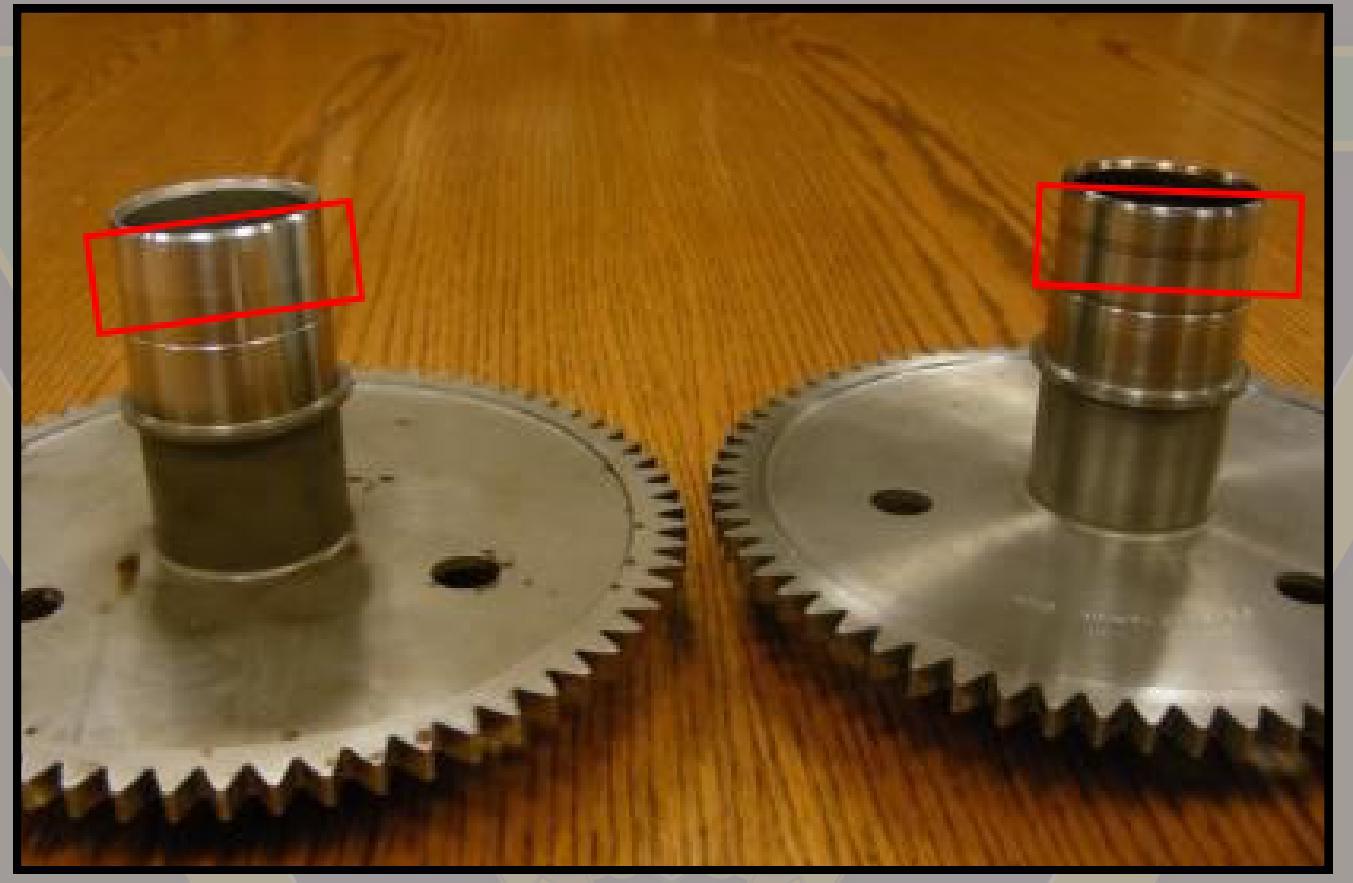
FLEET READINESS CENTER F/A-18E/F AMAD Hydraulic Gearshaft

Problem: Wear damage on the shaft of the Hydraulic Gear results in the gearbox leaking hydraulic fluid **Scope:** Gear replacement is D-Level overhaul

Solution: Conventional repair is Hard Chrome Plating, but wear testing proved Cold Spray is a superior wear resistant coating

Benefit: Over 90 Hydraulic Gearshafts have been repaired. Cost avoided are over \$150k

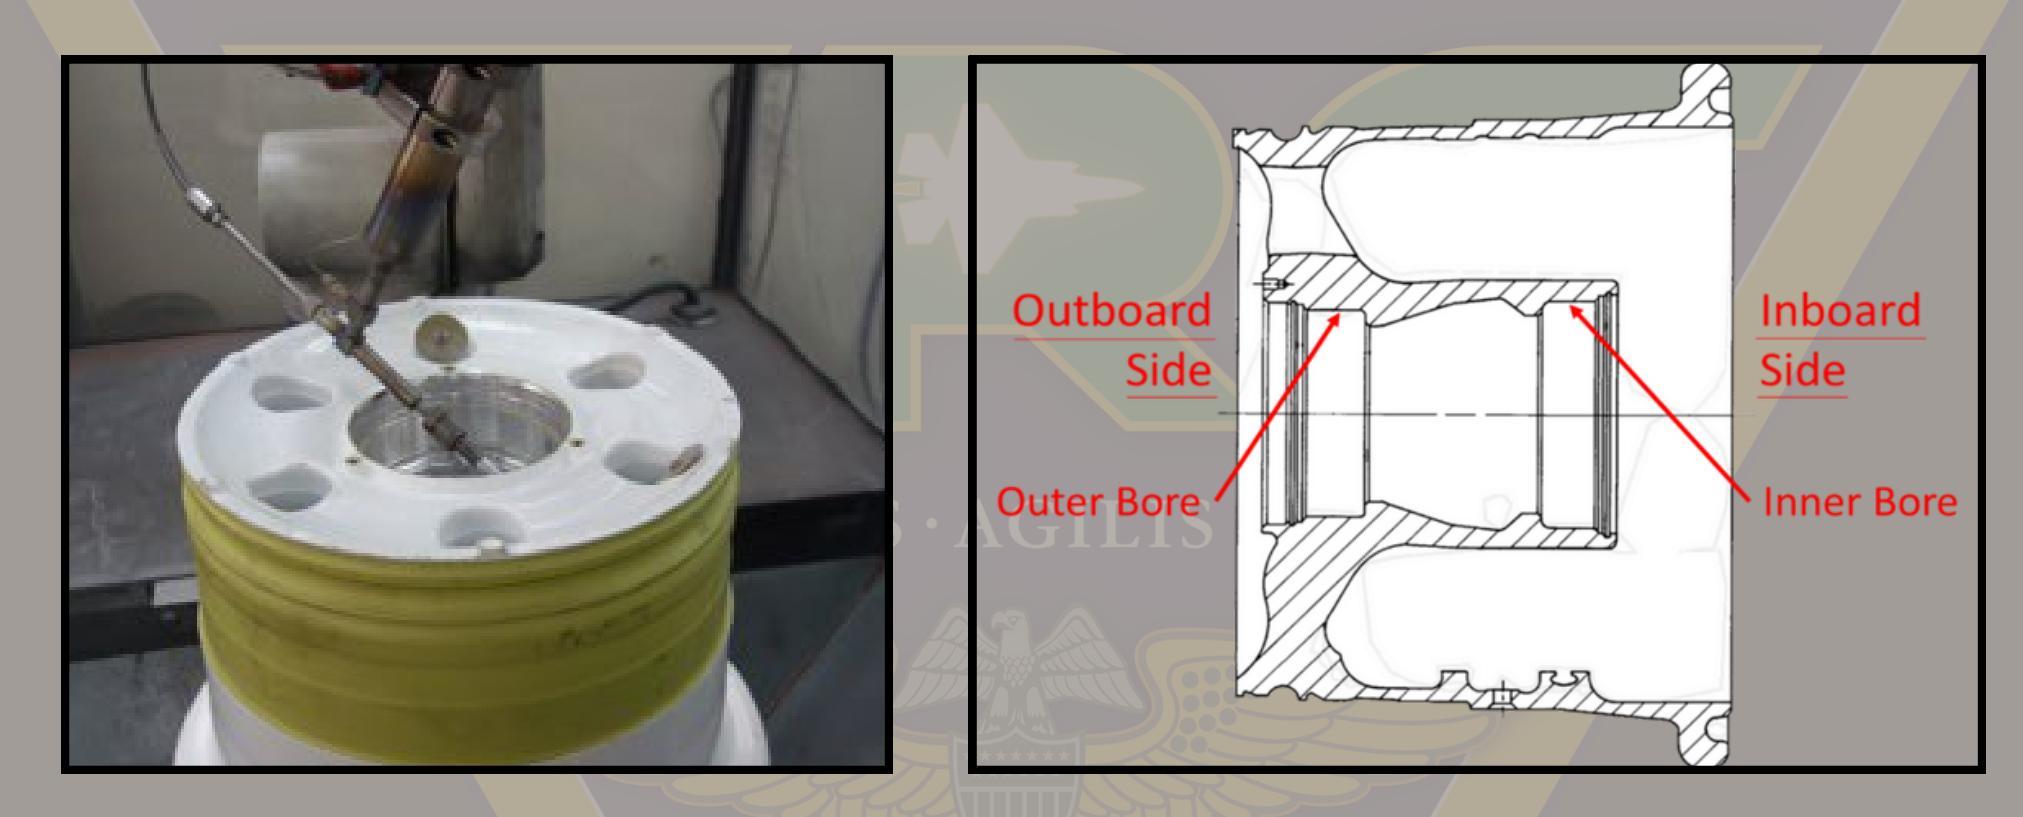
FLEET READINESS CENTER F/A-18E/F Main Landing Gear Wheel Bore

Problem: Corrosion and wear damage on the bores that hold the bearing race
 Loss of dimension results in bushing repair or scrapped asset
 Scope: New wheels have long lead-time and cost over \$90k
 Solution: Conventional repair is a one-time bushing repair. Cold Spray bushing conserves wheel strength
 Benefit: Cold Spray can be reapplied an unlimited amount of times
 Repair cost is reduced
 Increased life of asset
 Turnaround time is improved by 80%
